UNITED STATES ENVIRONMENTAL PROTECTION AGENCY

INSTALLATION NAME: Arcelor Mittal Burns Harbor, LLC

DATE OF RCRA INSPECTION: June 13, 14, 15, 20, 27 - 30, 2011

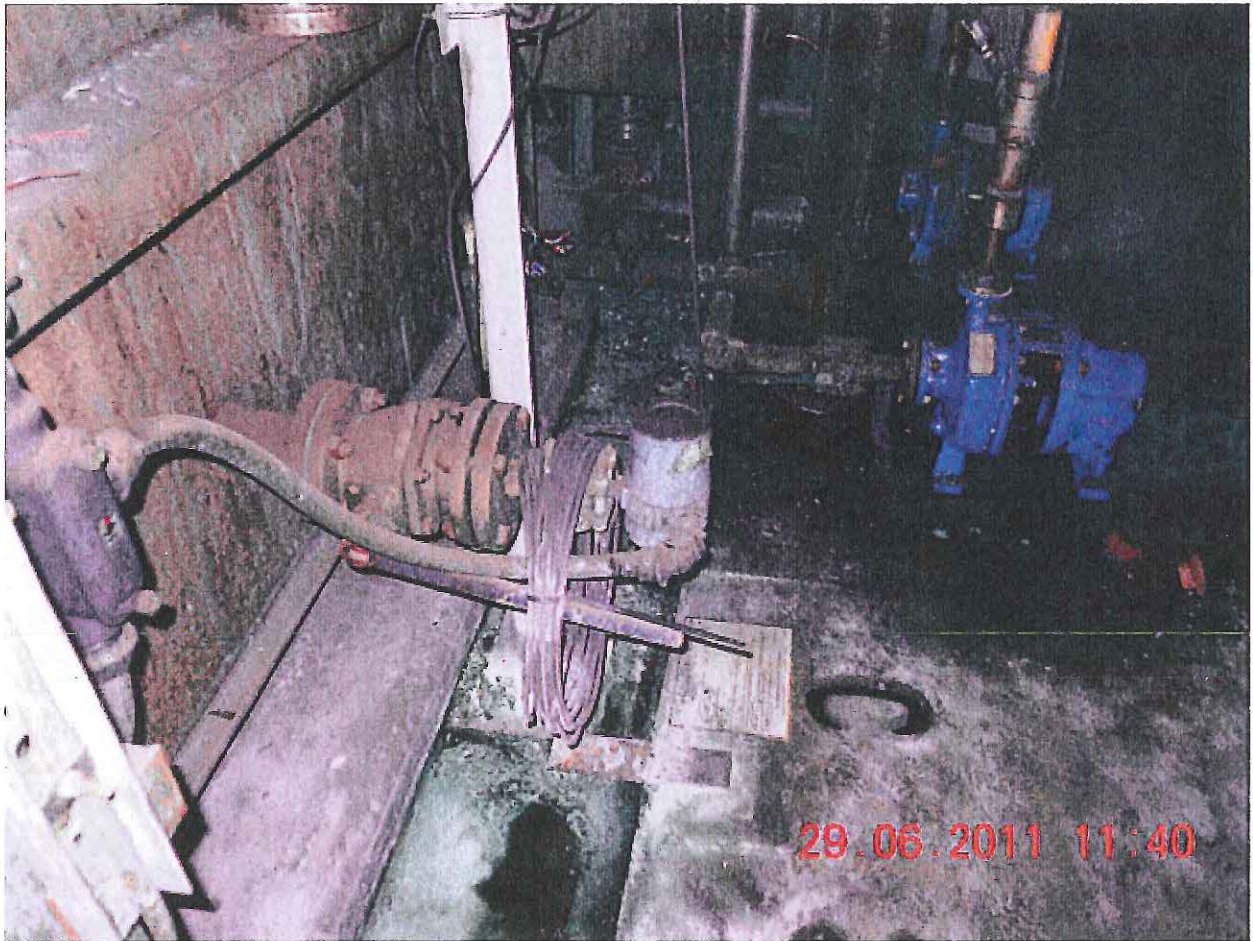
Facility: Arcelor Mittal, IND003913423
Location: 250 West US Highway 12, Burns Harbor, Indiana
Date: June 29, 2011, 11:40 a.m.
Photographer: Robert Dean Smith, LPG
Camera: Nikon Coolpix, 12.0 megapixels
Description: Photograph 61: Subbasement, phosphating area.

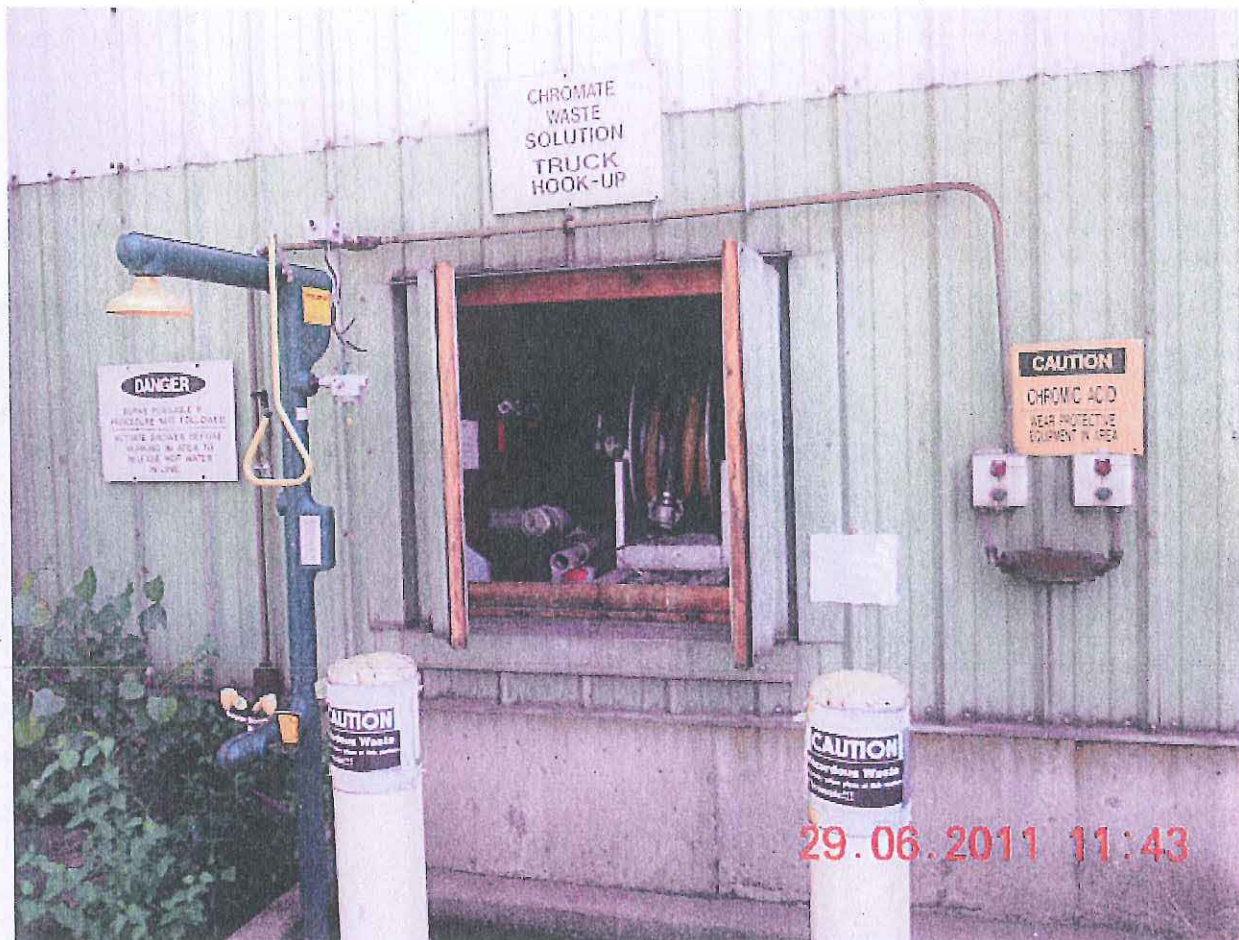
Facility: Arcelor Mittal, IND003913423
Location: 250 West US Highway 12, Burns Harbor, Indiana
Date: June 29, 2011, 11:43 a.m.
Photographer: Robert Dean Smith, LPG
Camera: Nikon Coolpix, 12.0 megapixels
Description: Photograph 62: Area where chromate waste is loaded onto waste trucks. Facing E.

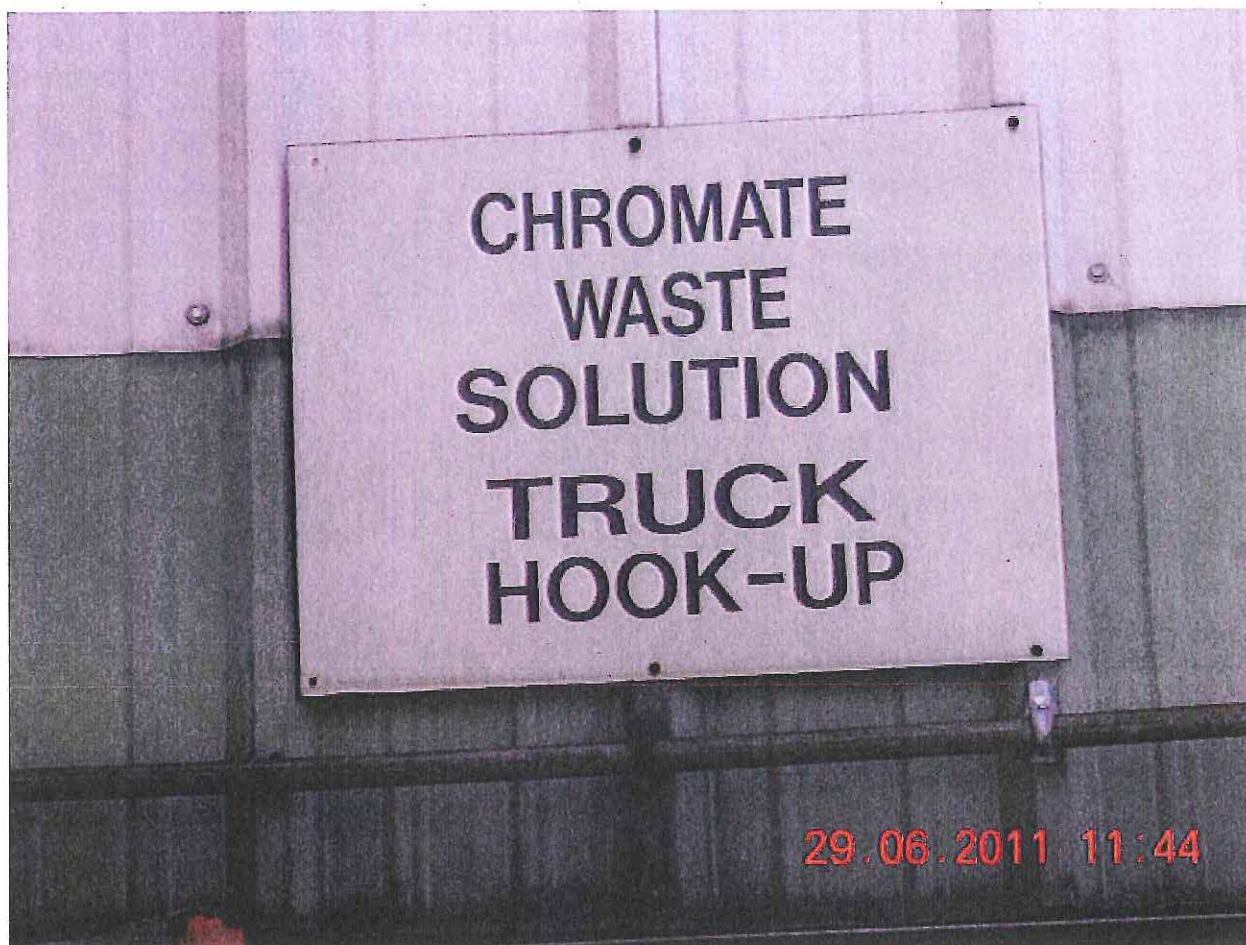
Facility: Arcelor Mittal, IND003913423
Location: 250 West US Highway 12, Burns Harbor, Indiana
Date: June 29, 2011, 11:44 a.m.
Photographer: Robert Dean Smith, LPG
Camera: Nikon Coolpix, 12.0 megapixels
Description: Photograph 63: Close up of sign identifying the area as where hazardous waste trucks hook up to load chromate waste.

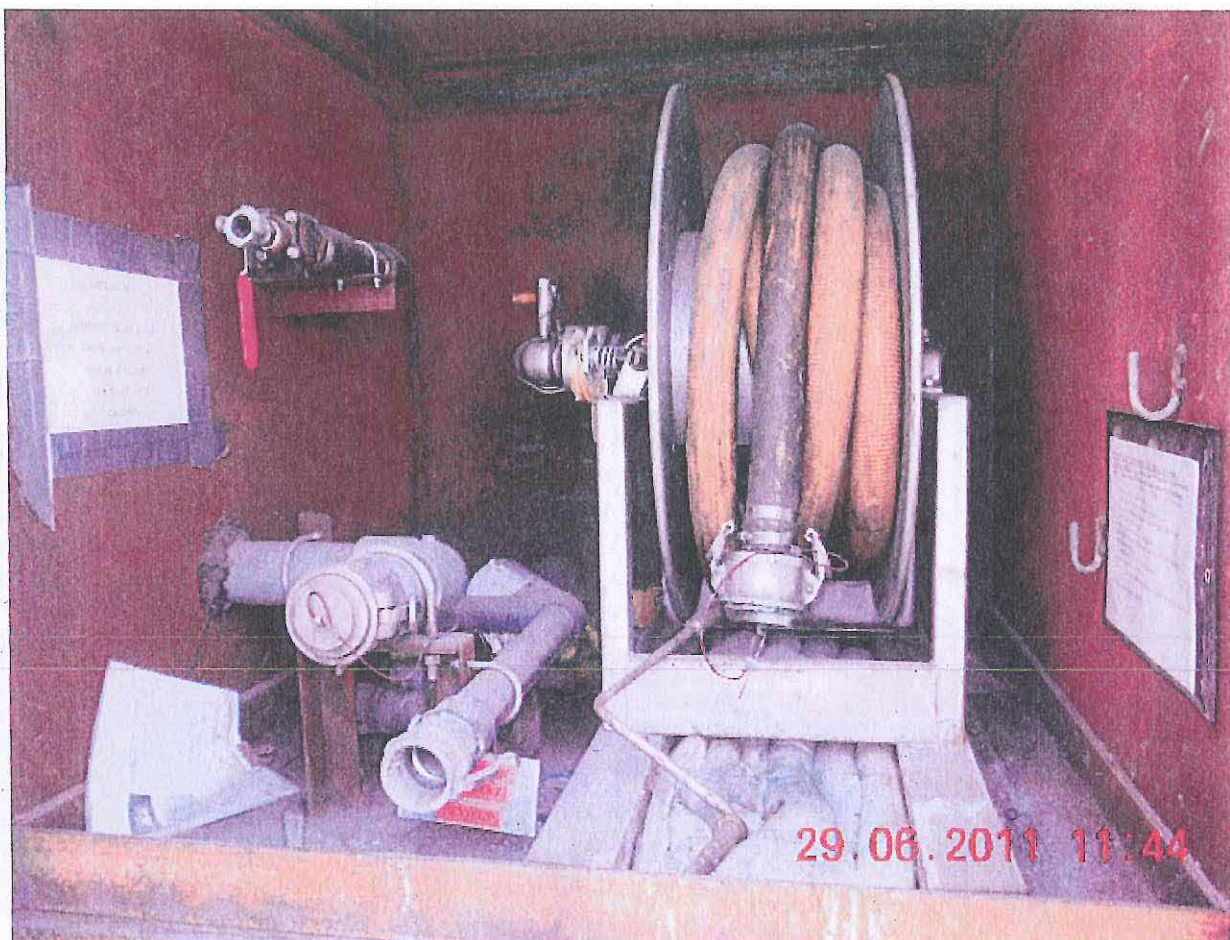
Facility: Arcelor Mittal, IND003913423
Location: 250 West US Highway 12, Burns Harbor, Indiana
Date: June 29, 2011 11:44 a.m.
Photographer: Robert Dean Smith, LPG
Camera: Nikon Coolpix, 12.0 megapixels
Description: Photograph 64: Interior of the pumping station where chromate waste is pumped into hazardous waste tanker trucks. Facing E.

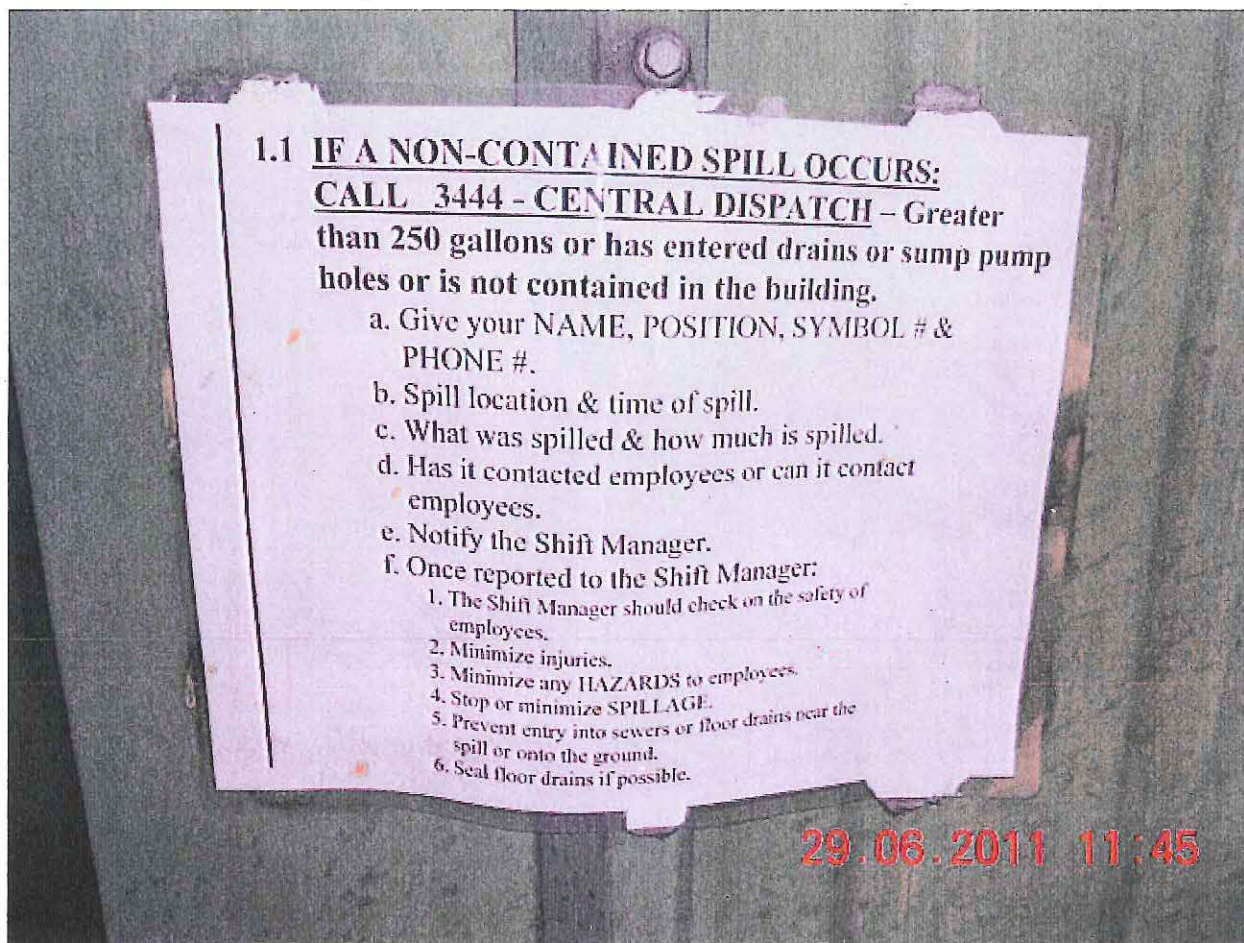
Facility: Arcelor Mittal, IND003913423
Location: 250 West US Highway 12, Burns Harbor, Indiana
Date: June 29, 2011, 11:45 a.m.
Photographer: Robert Dean Smith, LPG
Camera: Nikon Coolpix, 12.0 megapixels
Description: Photograph 65: Label within the pumping station for the chromate waste providing instruction for the event of a spill of hazardous waste.

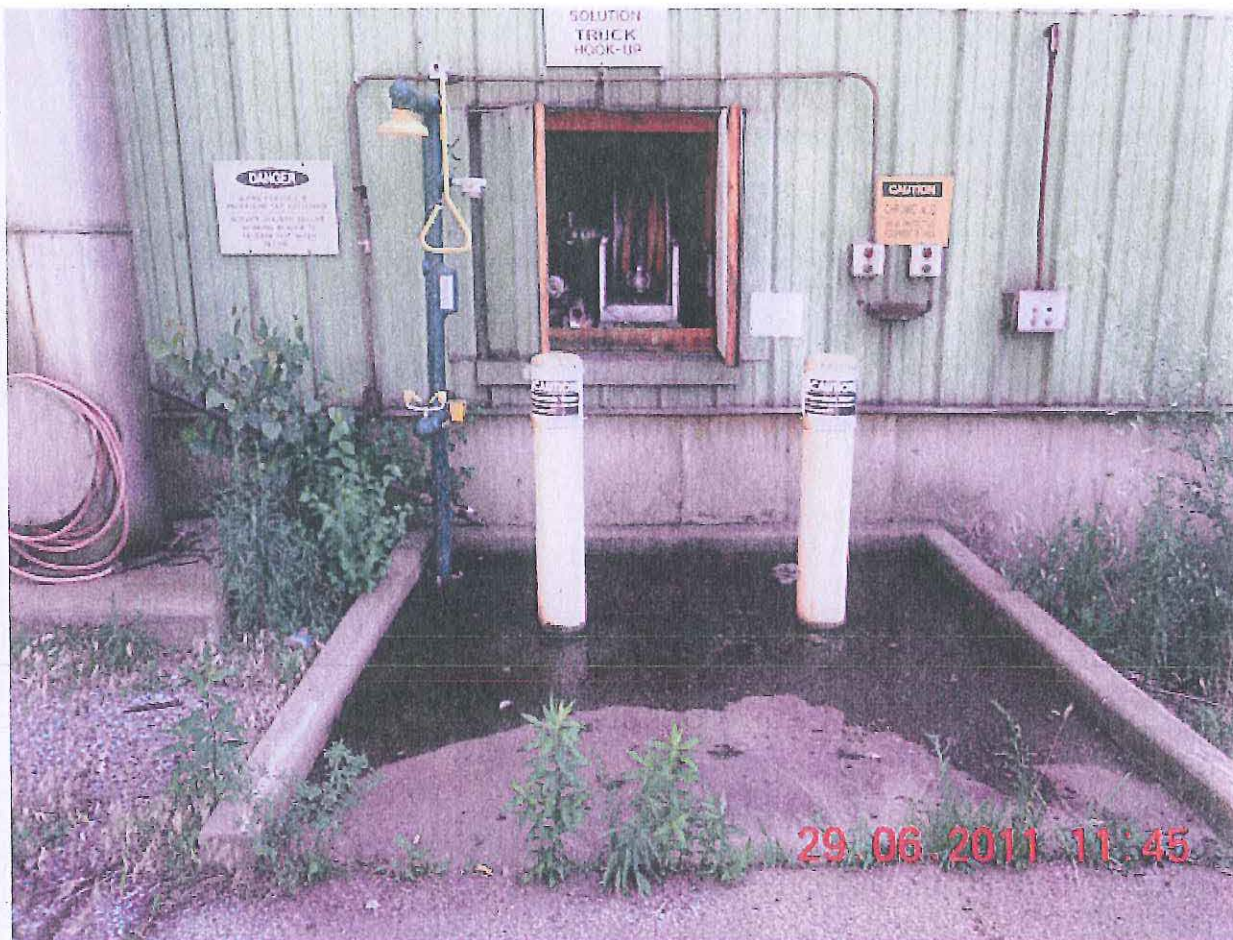
Facility: Arcelor Mittal, IND003913423
Location: 250 West US Highway 12, Burns Harbor, Indiana
Date: June 29, 11:45 a.m.
Photographer: Robert Dean Smith, LPG
Camera: Nikon Coolpix, 12.0 megapixels
Description: Photograph 66: Chromate waste loading area.

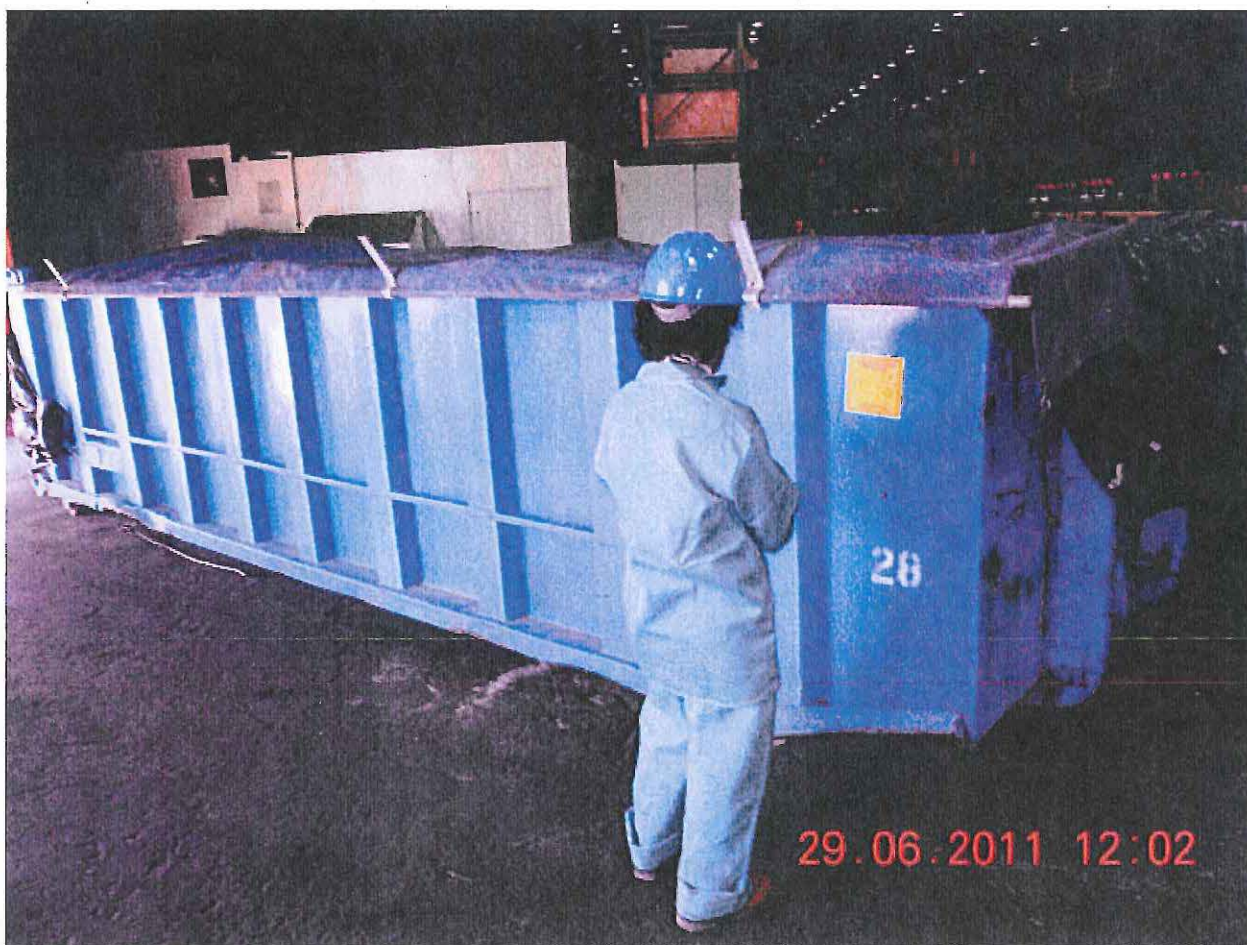
- Inspector Smith observed and photographed a roll-off box which accumulates swarf for off-site disposal. The roll-off box had a hazardous waste label, was stored closed, and was dated 6/27/11 (photographs 67 and 68).

Facility: Arcelor Mittal, IND003913423
Location: 250 West US Highway 12, Burns Harbor, Indiana
Date: June 29, 2011, 12:02 p.m.
Photographer: Robert Dean Smith, LPG
Camera: Nikon Coolpix, 12.0 megapixels
Description: Photograph 67: Hazardous waste roll-off box, dated June 27, 2011. The box contains hazardous waste swarf. Swarf is the grinding sludge generated from the grinding of rolls that contain chrome or are chrome plated.

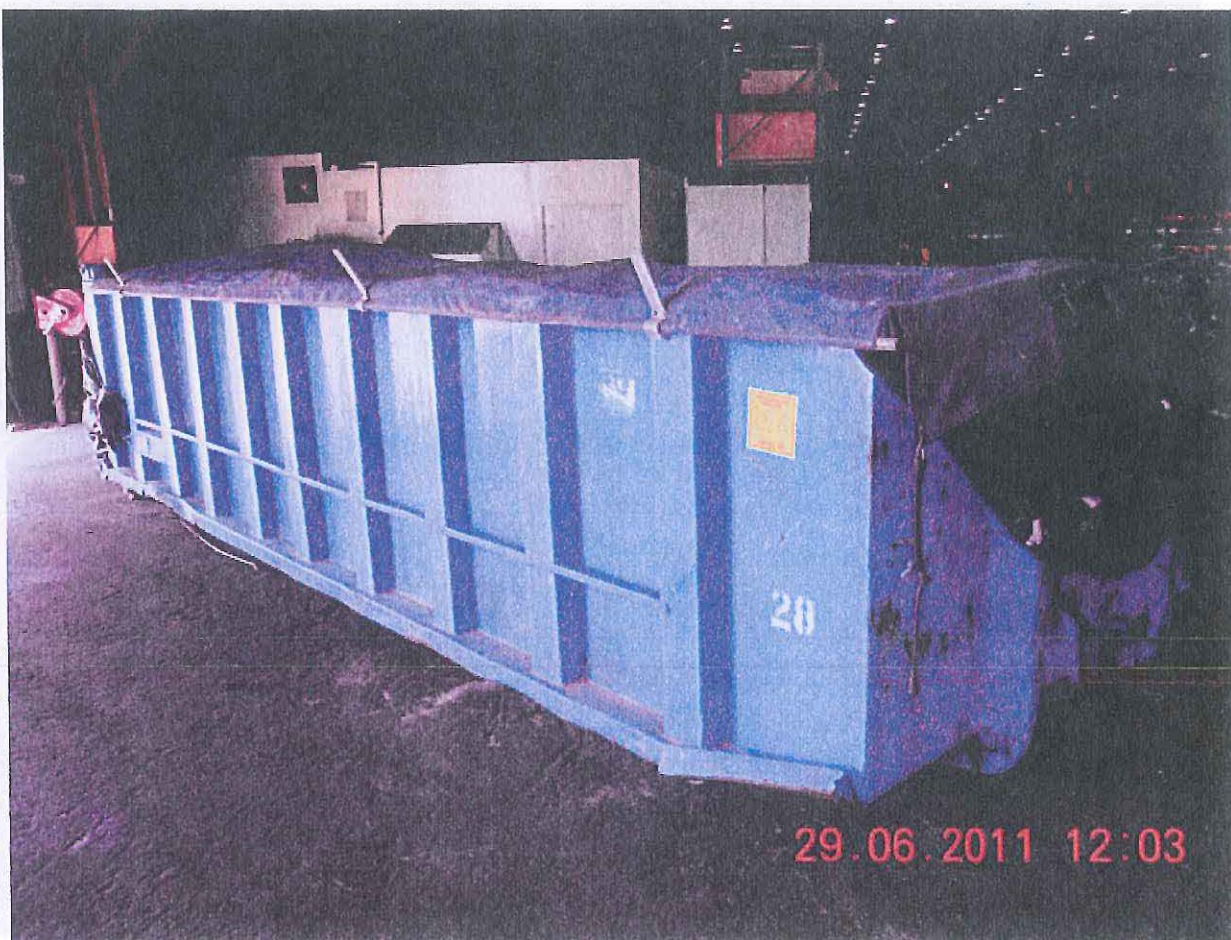
Facility: Arcelor Mittal, IND003913423
Location: 250 West US Highway 12, Burns Harbor, Indiana
Date: June 29, 2011, 12:03 p.m.
Photographer: Robert Dean Smith, LPG
Camera: Nikon Coolpix, 12.0 megapixels
Description: Photograph 68: A second photograph of the swarf hazardous waste roll-off box that contains hazardous waste swarf. The roll off box goes to EQ in Harvey, Illinois.

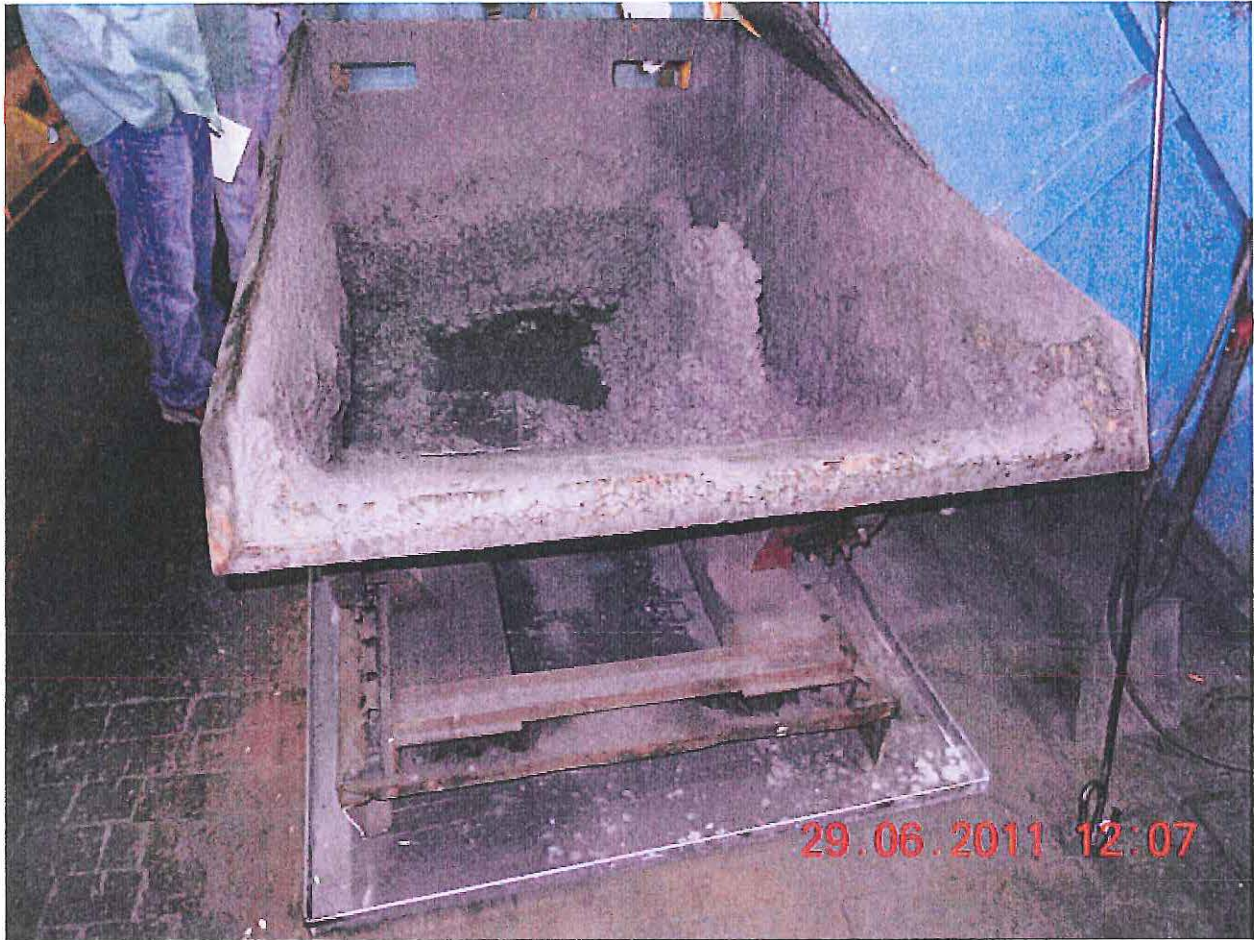
- Inspector Smith observed and photographed the hazardous waste hopper for grinder number 6 (photograph 69 and 72).
- Inspector Smith observed and photographed the pit in which swarf is collected for grinder number 6. The pit collects the grindings from the rolls, a dredge continuously pulls the swarf up and out of the pit and places the swarf into the hopper seen in photograph 69 (photograph 70).

Facility: Arcelor Mittal, IND003913423
Location: 250 West US Highway 12, Burns Harbor, Indiana
Date: June 29, 2011, 12:07 p.m.
Photographer: Robert Dean Smith, LPG
Camera: Nikon Coolpix, 12.0 megapixels
Description: Photograph 69: Number 6 grinder hopper with hazardous waste swarf. The process is continuous and therefore does not need a cover. Secondary containment is located beneath the hopper.

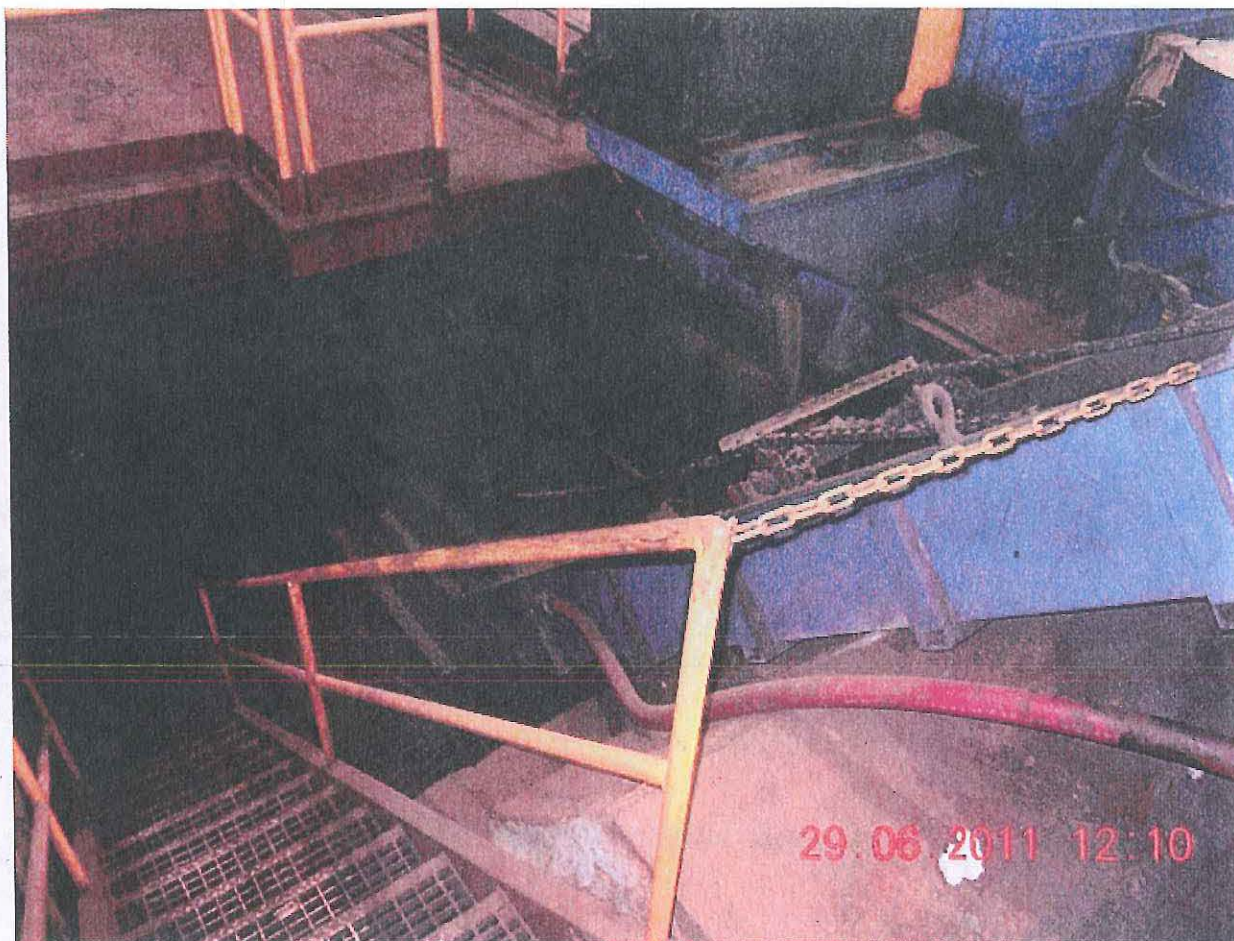
Facility: Arcelor Mittal, IND003913423
Location: 250 West US Highway 12, Burns Harbor, Indiana
Date: June 29, 2011, 12:10 a.m.
Photographer: Robert Dean Smith, LPG
Camera: Nikon Coolpix, 12.0 megapixels
Description: Photograph 70: Dredge for the waste pit that collects swarf from grinder 6. The dredge runs continuously; if it stopped, it would be impossible to restart. Thus, the hopper is continuously being filled.

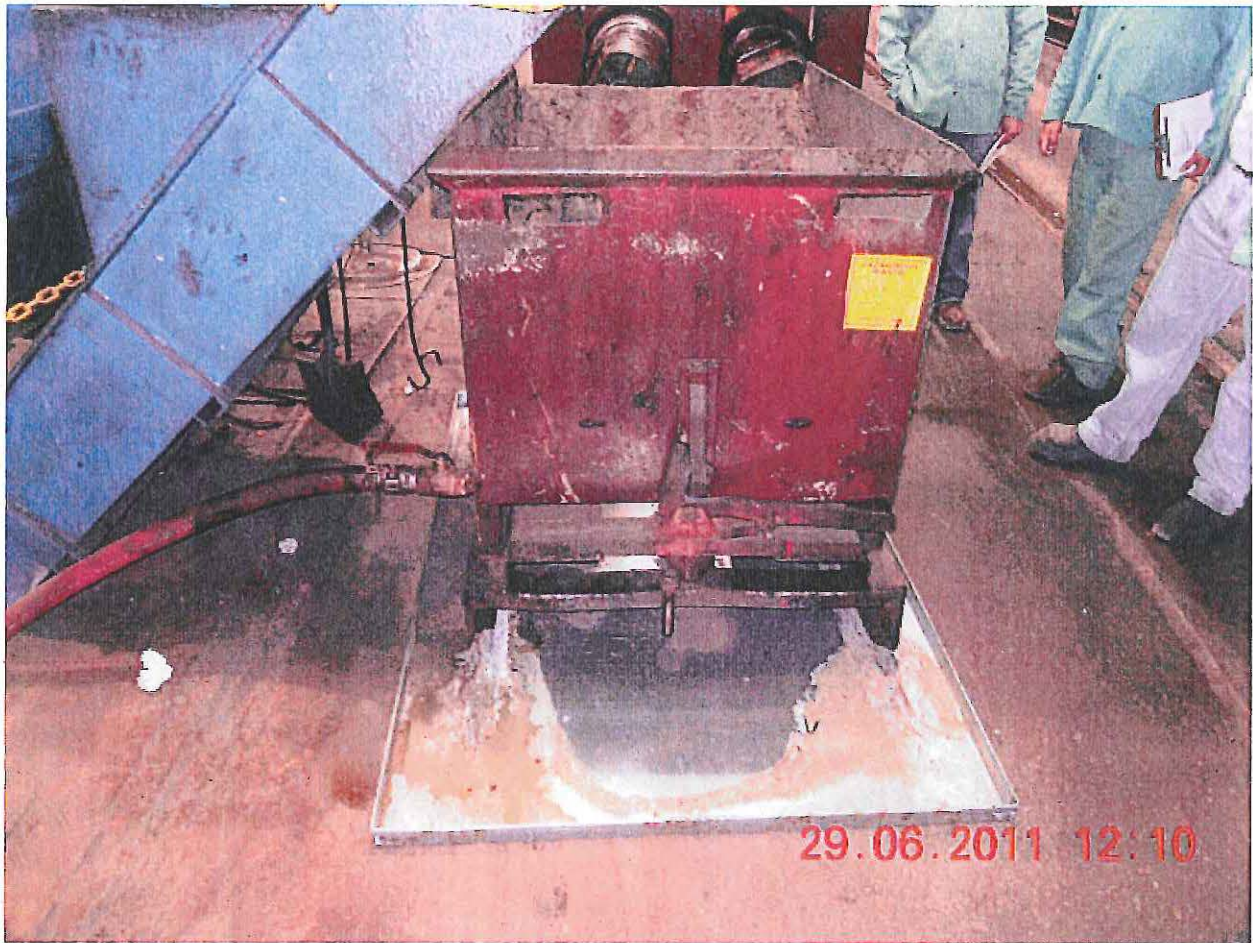
- Inspector Smith observed and photographed the secondary containment for the hazardous waste hopper for grinder number 6 (photograph 71).
- Inspector Smith observed and photographed the hazardous waste hoppers for grinders numbers 5 and 6 (photograph 73).

Facility: Arcelor Mittal, IND003913423
Location: 250 West US Highway 12, Burns Harbor, Indiana
Date: June 29, 2011, 12:10 p.m.
Photographer: Robert Dean Smith, LPG
Camera: Nikon Coolpix, 12.0 megapixels
Description: Photograph 71: Hopper for grinder number 6, showing the secondary containment pan.

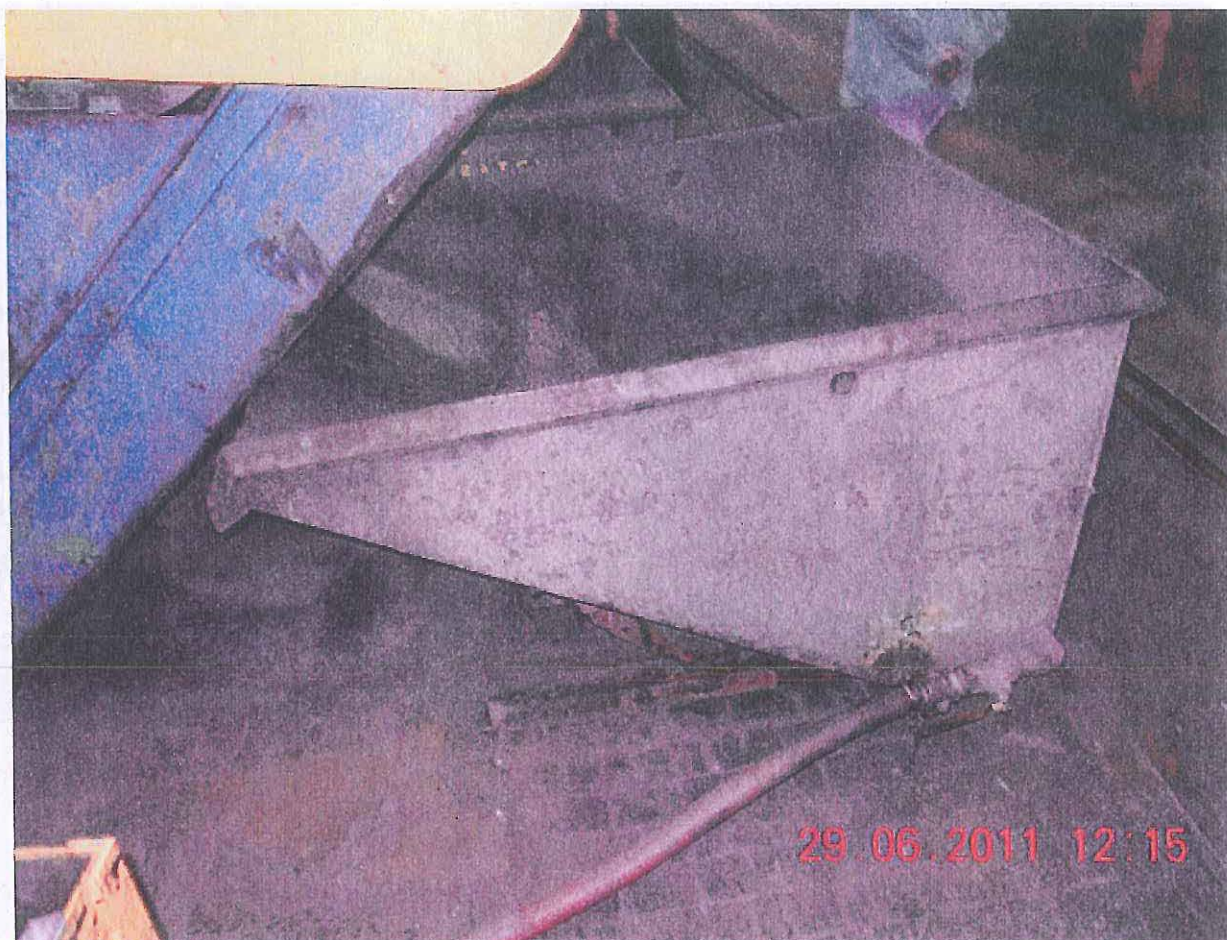
Facility: Arcelor Mittal, IND003913423
Location: 250 West US Highway 12, Burns Harbor, Indiana
Date: June 29, 2011, 12:15 p.m.
Photographer: Robert Dean Smith, LPG
Camera: Nikon Coolpix, 12.0 megapixels
Description: Photograph 72: Hopper for grinding waste.

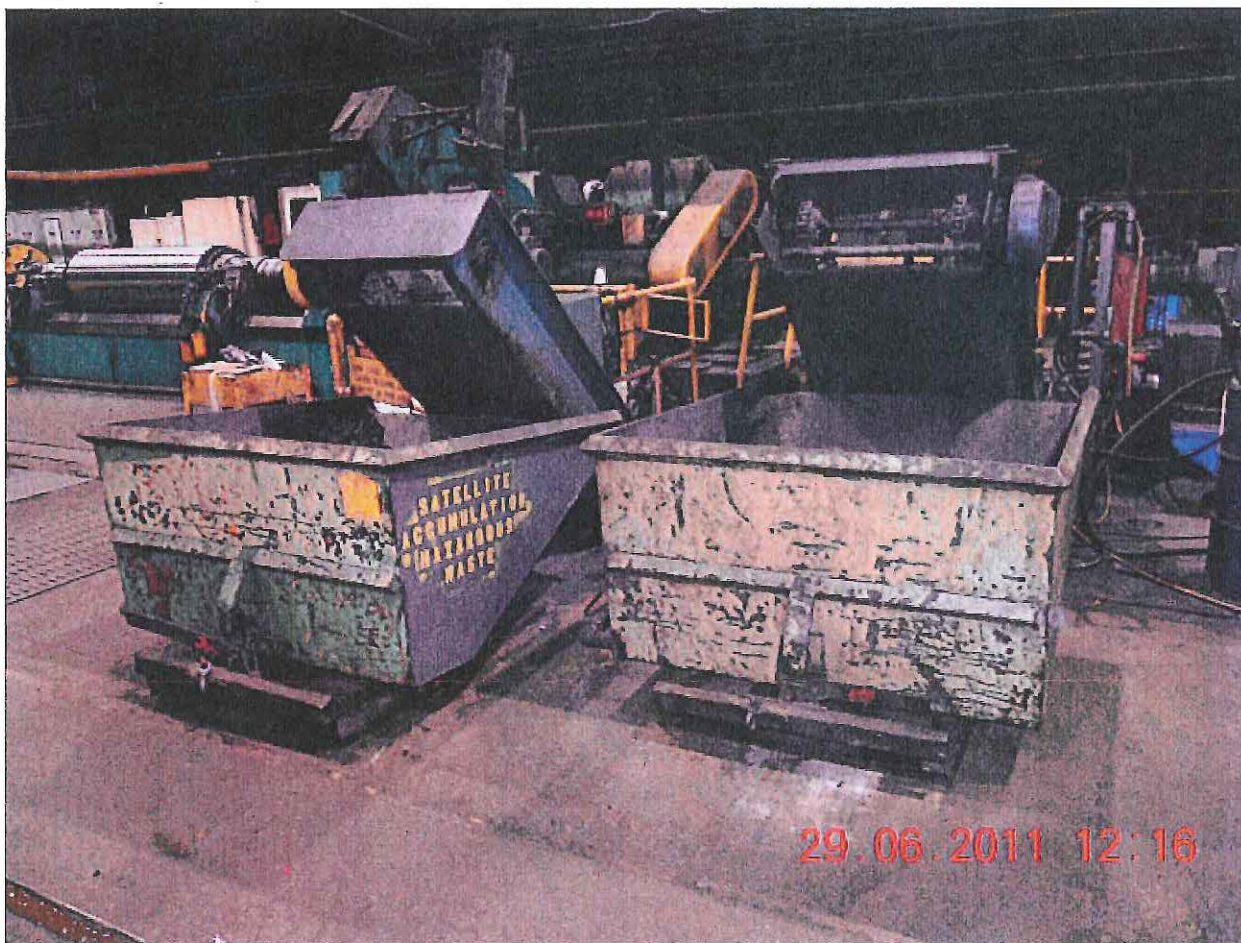
Facility: Arcelor Mittal, IND003913423
Location: 250 West US Highway 12, Burns Harbor, Indiana
Date: June 29, 2011, 12:16 p.m.
Photographer: Robert Dean Smith, LPG
Camera: Nikon Coolpix, 12.0 megapixels
Description: Photograph 73: Hopper for grinder number 5 is on the left and the hopper for grinder number 4 is on the right.

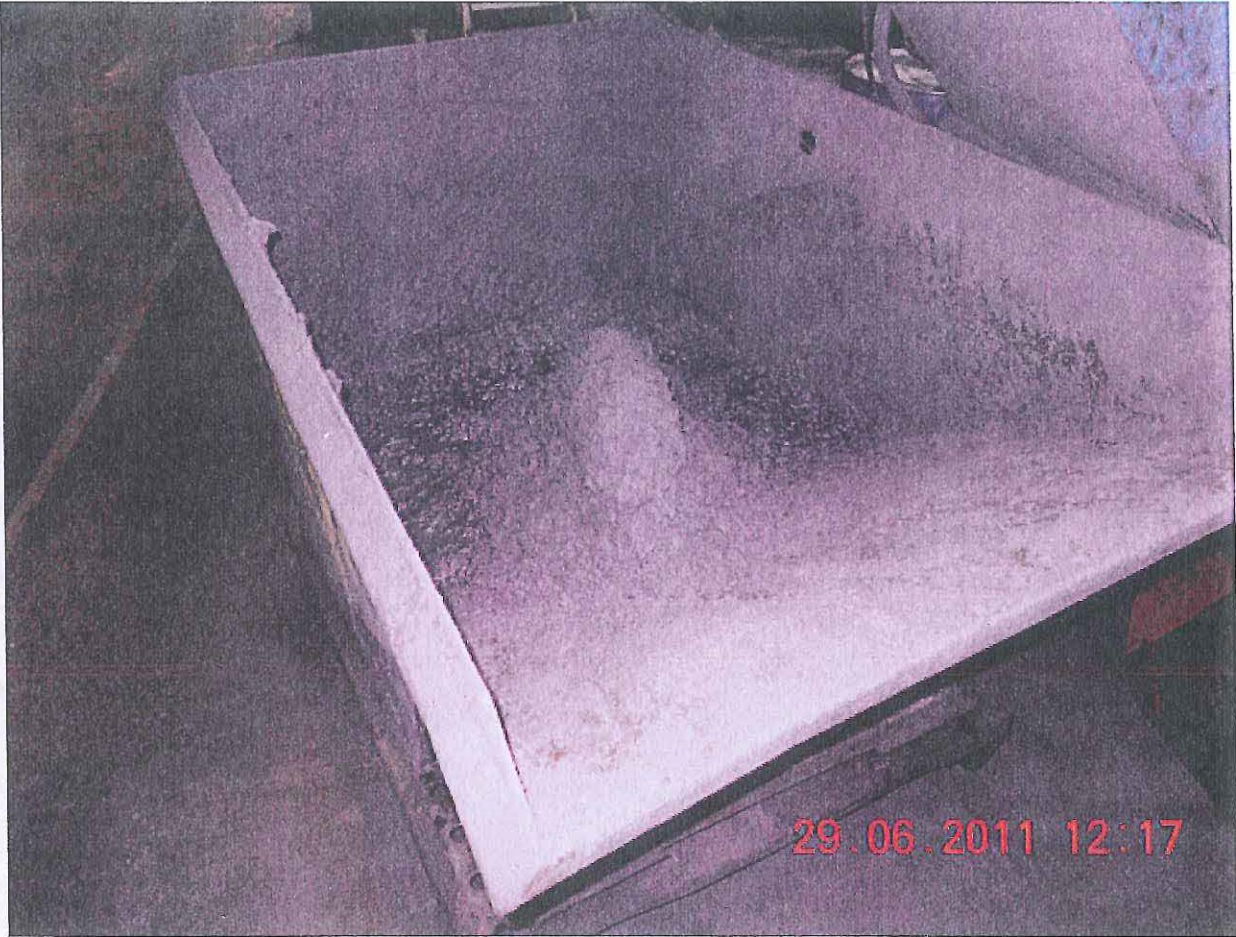
- Inspector Smith observed and photographed the interior of the hazardous waste hopper for grinder number 3 (photograph number 74).
- Inspector Smith observed and photographed the hazardous waste hopper and secondary containment for grinder number 3 (photograph 75).

Facility: Arcelor Mittal, IND003913423
Location: 250 West US Highway 12, Burns Harbor, Indiana
Date: June 29, 2011, 12:17 p.m.
Photographer: Robert Dean Smith, LPG
Camera: Nikon Coolpix, 12.0 megapixels
Description: Photograph 74: Interior for hopper for grinder number 3.

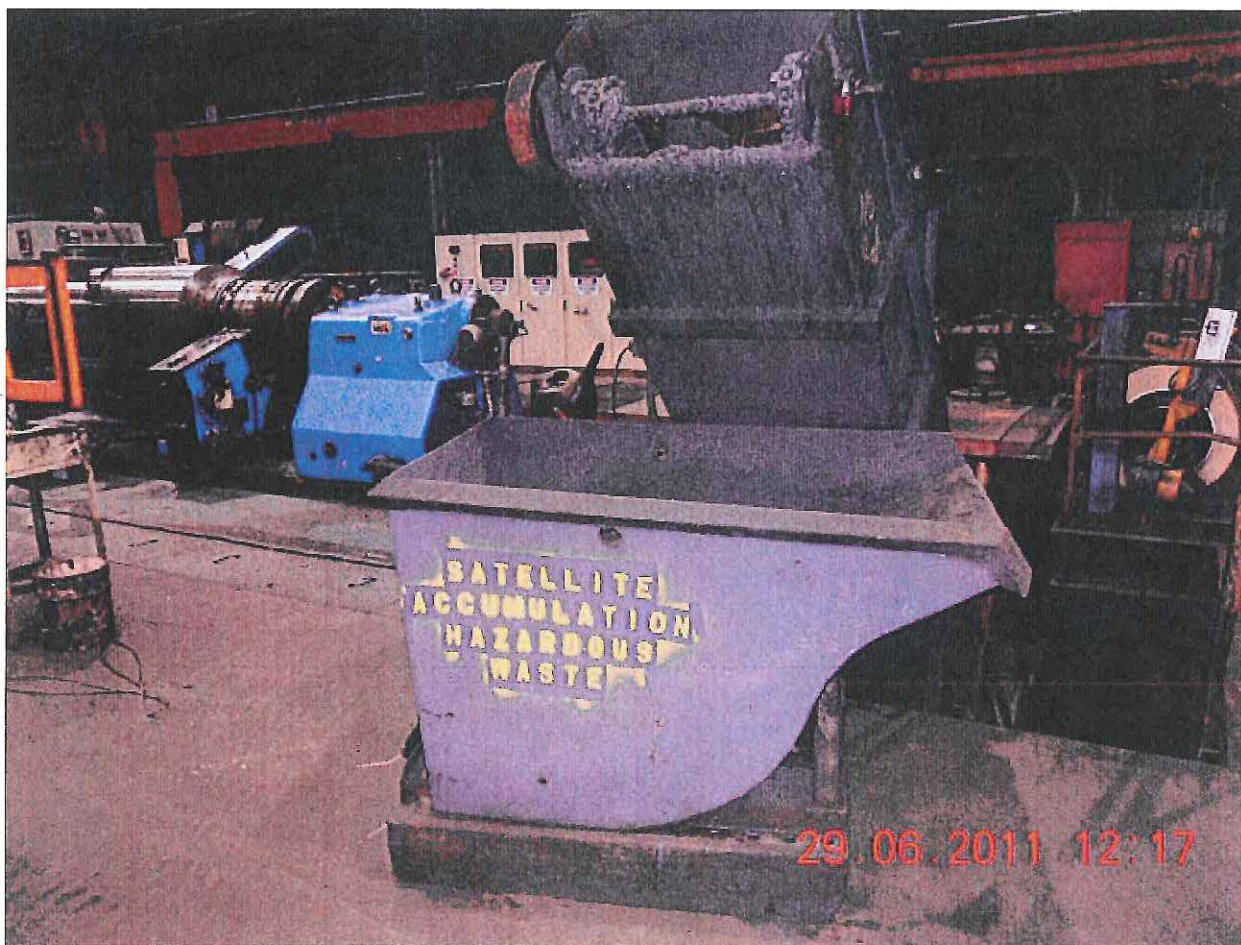
Facility: Arcelor Mittal, IND003913423
Location: 250 West US Highway 12, Burns Harbor, Indiana
Date: June 29, 2011, 12:17 p.m.
Photographer: Robert Dean Smith, LPG
Camera: Nikon Coolpix, 12.0 megapixels
Description: Photograph 75: Hopper for grinder number 3.

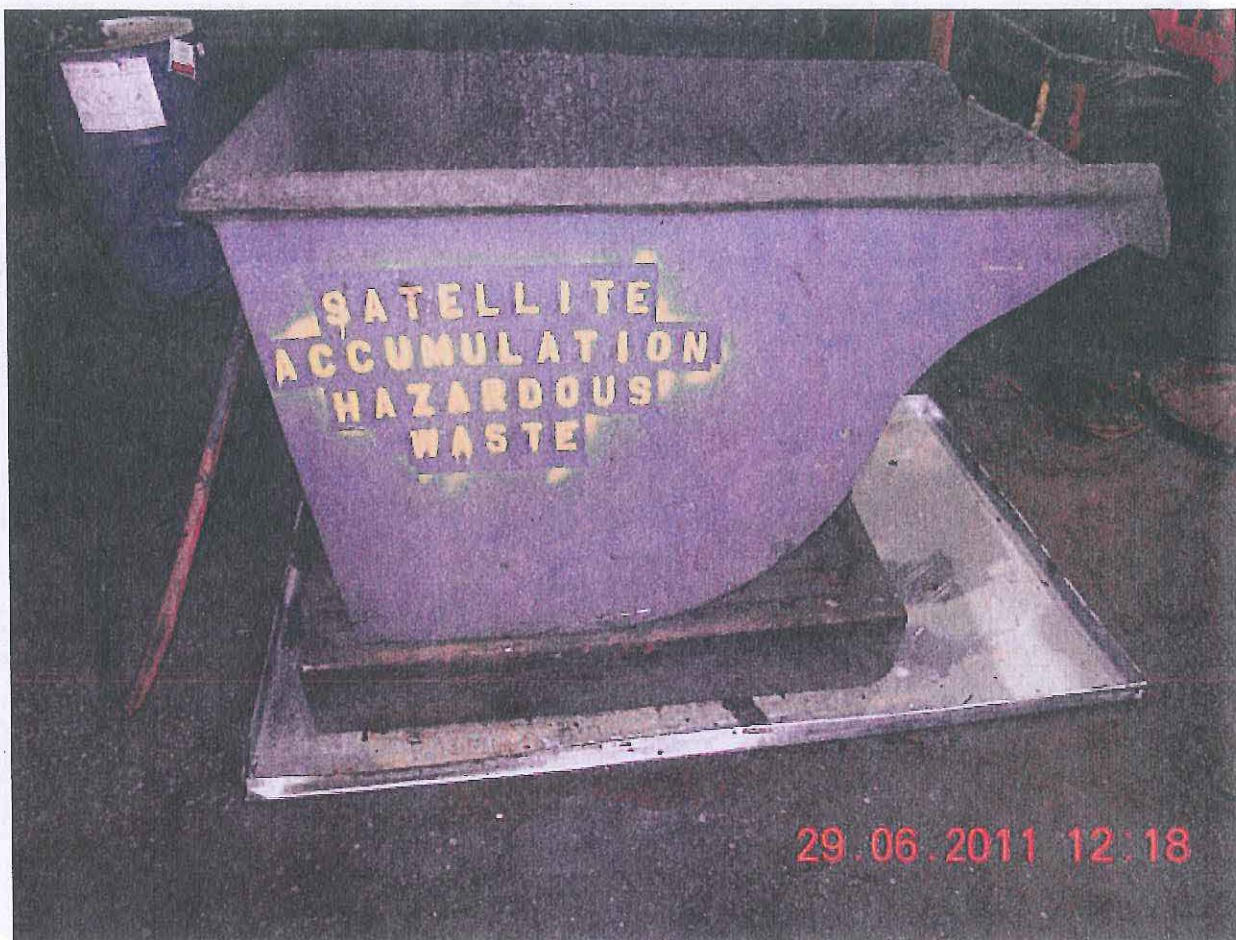
- Inspector Smith observed and photographed the hazardous waste hopper and secondary containment for grinder number 2 (photograph 76).
- Inspector Smith observed and photographed the hazardous waste hopper and secondary containment for grinder number 1 (photograph 77).

Facility: Arcelor Mittal, IND003913423
Location: 250 West US Highway 12, Burns Harbor, Indiana
Date: June 29, 2011, 12:18 p.m.
Photographer: Robert Dean Smith, LPG
Camera: Nikon Coolpix, 12.0 megapixels
Description: Photograph 76: Hopper for grinder number 2, with secondary containment.

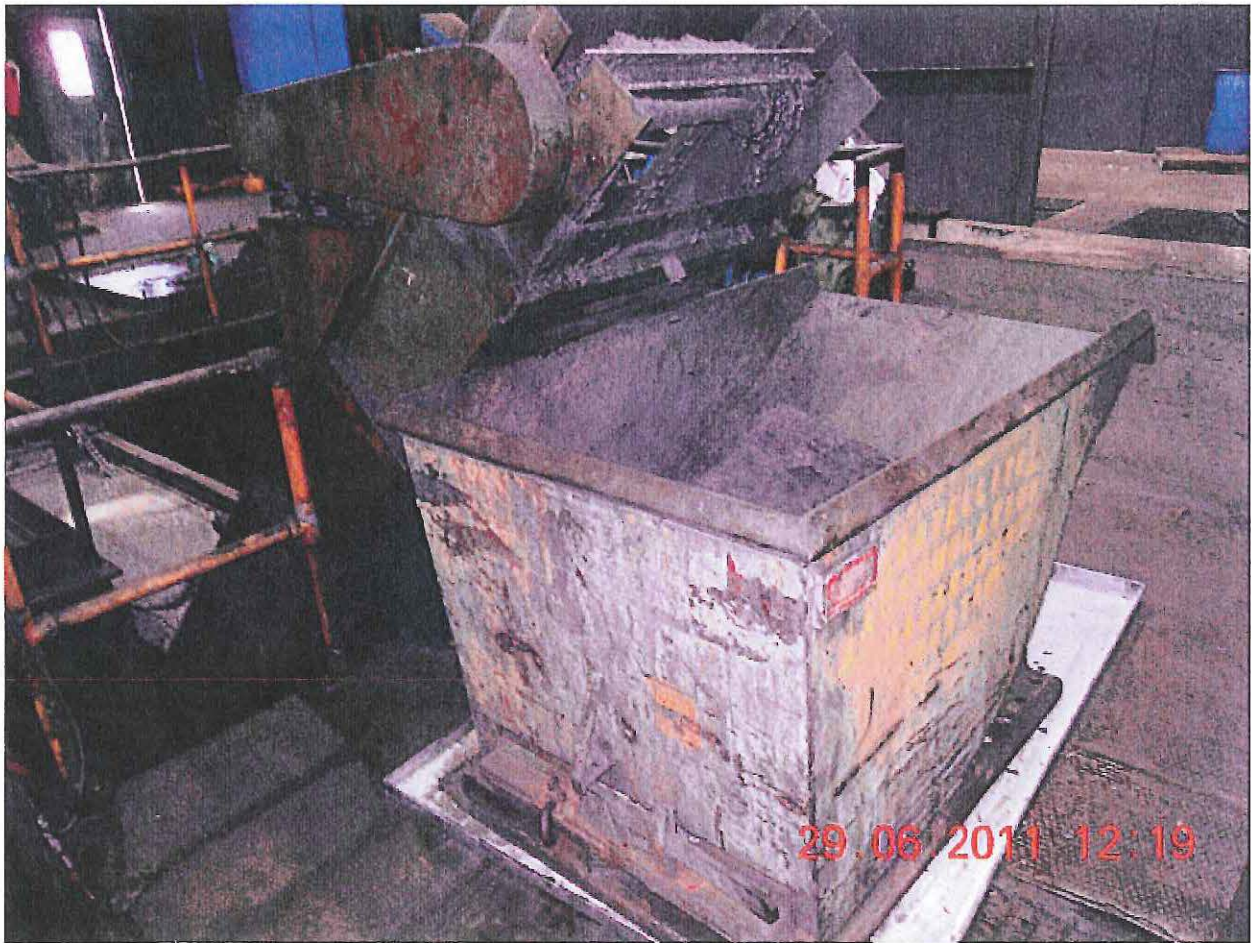
Facility: Arcelor Mittal, IND003913423
Location: 250 West US Highway 12, Burns Harbor, Indiana
Date: June 29, 2011, 12:19 p.m.
Photographer: Robert Dean Smith, LPG
Camera: Nikon Coolpix, 12.0 megapixels
Description: Photograph 77: Hopper for grinder number 1. Secondary containment is found beneath the hopper.

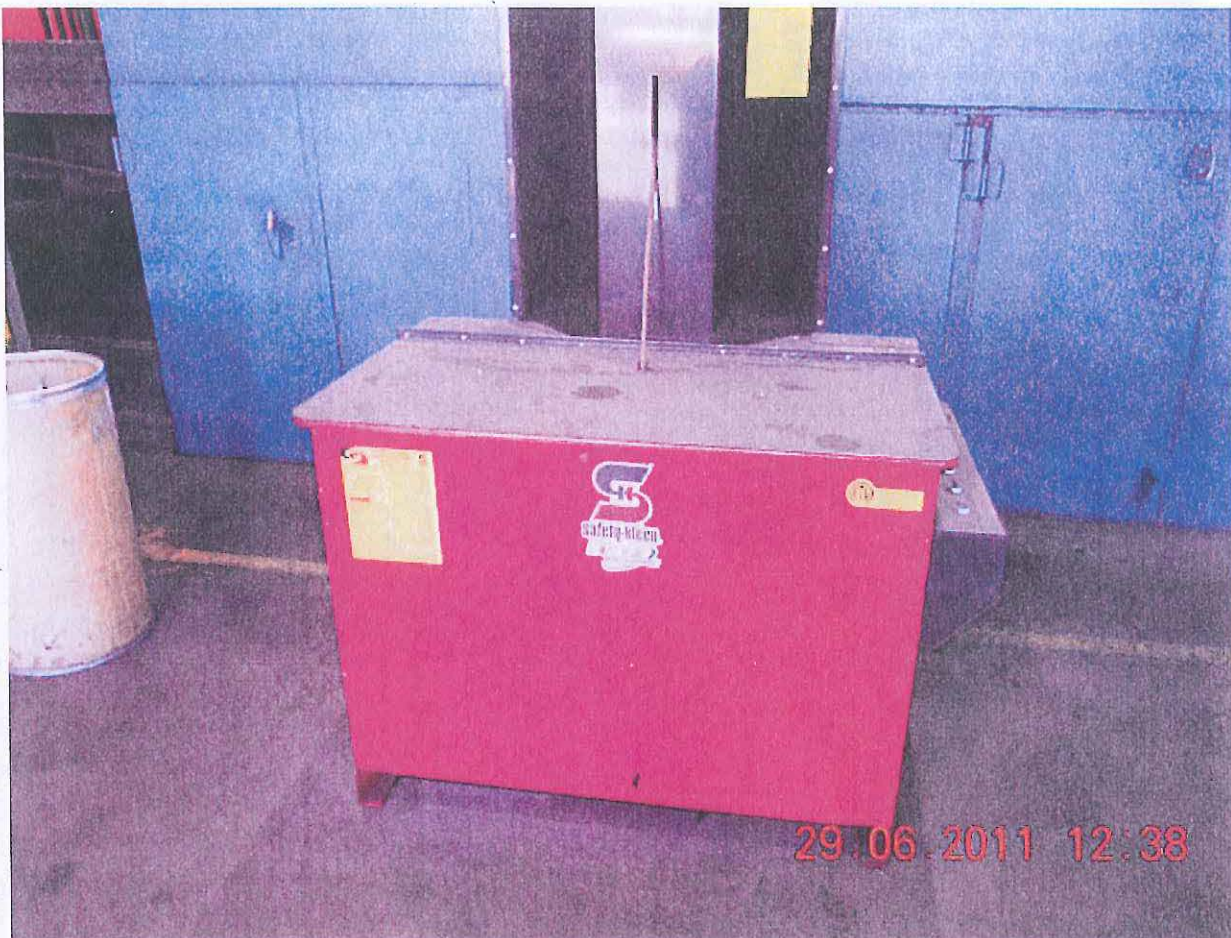
Facility: Arcelor Mittal, IND003913423
Location: 250 West US Highway 12, Burns Harbor, Indiana
Date: June29, 2011, 12:38 p.m.
Photographer: Robert Dean Smith, LPG
Camera: Nikon Coolpix, 12.0 megapixels
Description: Photograph 78: Parts washer in maintenance shop. Facing E.
